Large Power Plant 123 Power Road New England

Re: Unit 1-B Main Boiler Feed Pump Rotor Inspection

Ingersoll-Rand M/N 5CHTA

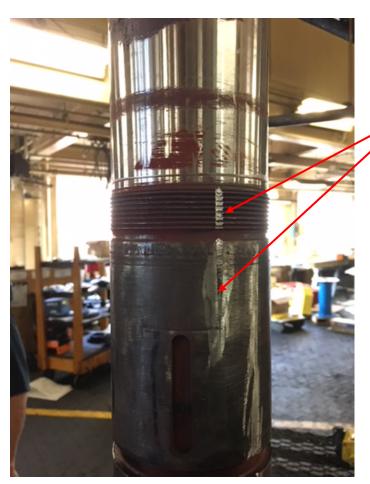
Old style threaded shaft design for retaining and adjusting the rotor centralization. Threads are damage and signs of water cutting under the drum

Newer design utilizes a split ring and retainer collar with an interference fit to the shaft as shown on the next page

- Provide an upgraded shaft with the split ring retainer feature for the balance drum
- Furnish a new shaft in 410SS
- Rough machine to within 0.06"
- Stress relieve by heat treating
- Machine to within 0.030" of final dimensions
- Prepare and chrome plate both bearing journals and balance drum fit area
- Hard chrome areas to be ground to plan dimensions
- Cut all keyways
- Finish machine all diameters and threads to final sizes
- Inspect complete and furnish all new keys
