CIRCULATING WATER PUMP TURNKEY EMERGENCY REPAIR CASE NO AP-321

Chas G Allen received an emergency request to repair a Johnston Model 58KLC-1, rated 58,000GPM @ 46'TDH. The unit provides cooling water to a 550 Mw combine cycle station. CGA received the call from the plant on Sunday to evaluate the unit and found that the shaft had broken internally. As a turnkey service CGA provide field personnel to remove the equipment on a 24/7 basis. The unit was transported to our service center, disassembled and evaluated for a corrective action plan. The internal shaft coupling had fracture and caused the unit failure. A new coupling was manufacture and the pump was reinstalled at the site within six 6 days of the initial call. The following pages include the opening inspection and final report of the project.

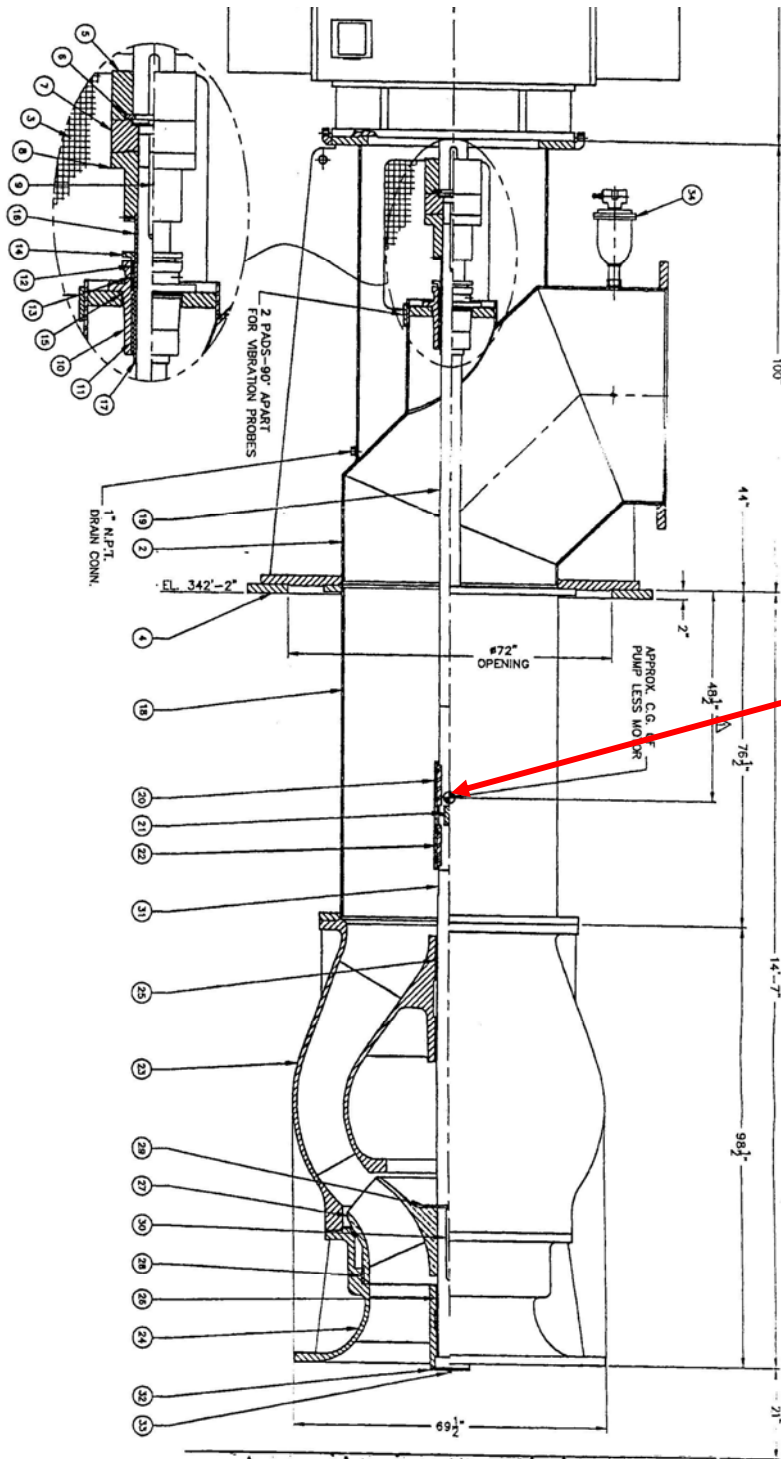
- Coupling gap after removing bolting 3/8" (Std. 5/8" off bottom)
- Note the pump shaft could be turn by hand, which should have had a weight of 3,100 Lbs as an assemble indicating a fracture
- The motor support was previously shimmed for alignment, indicating the discharge head needs to machine with the stuffing/bearing
- One discharge head stud under the flange in restricted clearance area had to be cutoff to facilitate removal

Internal Shaft coupling fracture at keyway

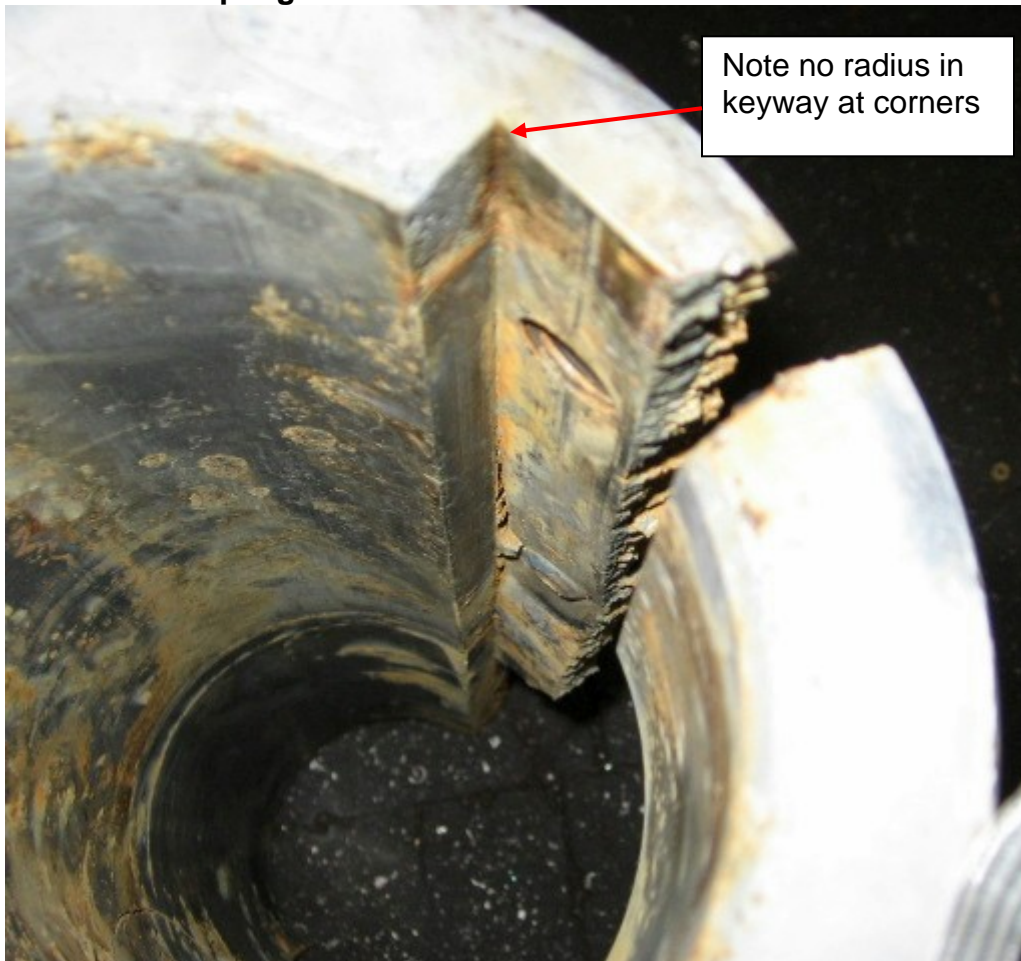
#20 Shaft Coupling

- #19 Lower Head Shaft- .002" TIR Good Condition for one cycle
- #20 Shaft Coupling-Fracture, replace new in 416SS, with upgrades
- #23 Discharge Bowl-Good condition clean and reuse

Recommendations:

- Manufacture a new shaft coupling in 416SS forging, with modifications to the wall thickness and keyway radius

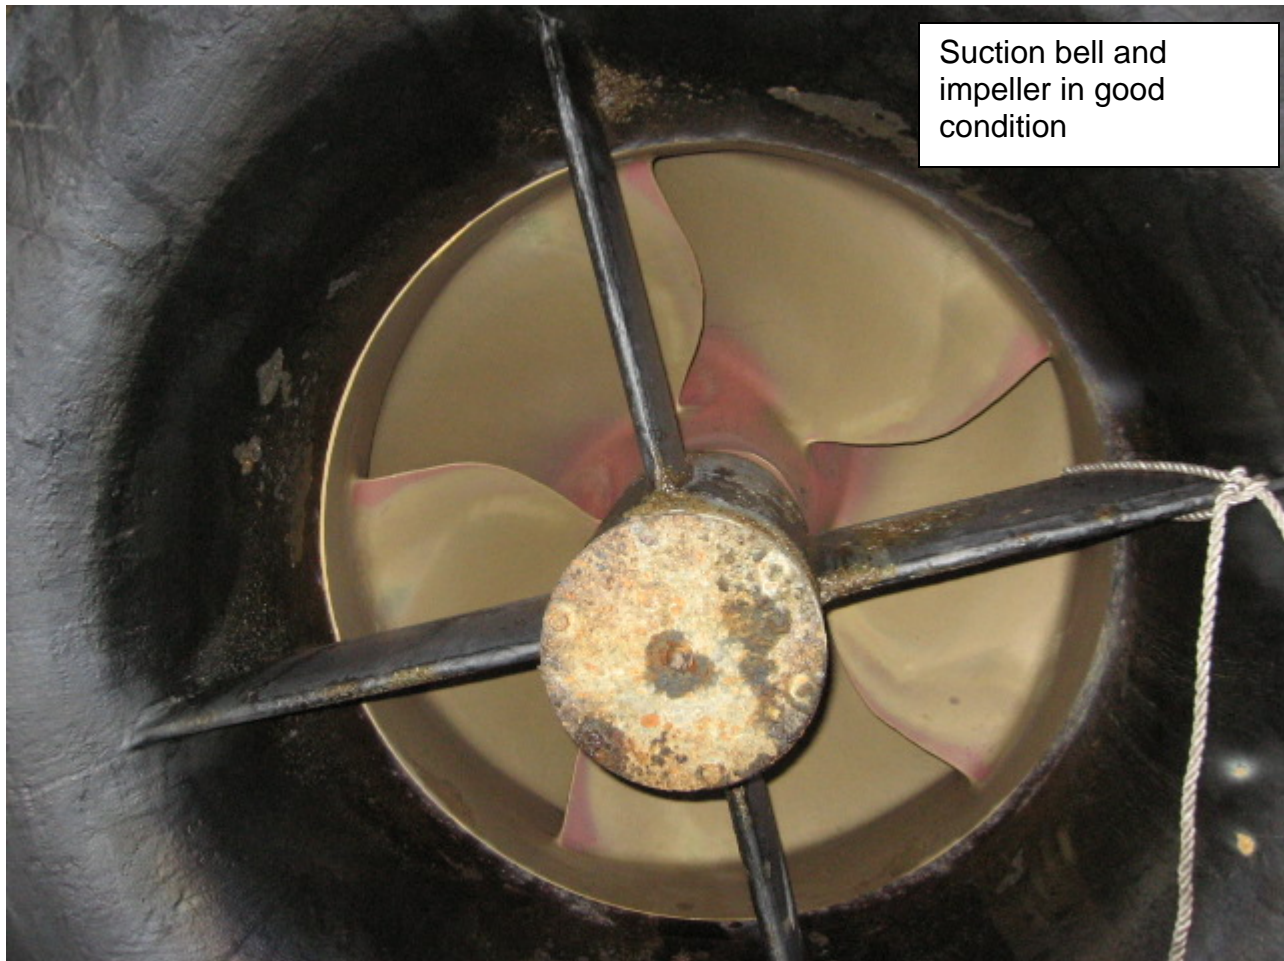
#24 Suction Bell

- #24 Suction Bell-Good condition clean and reuse
- #25 Bearing Discharge Bowl-.014" clearance, clean and reuse
- #26 Bearing-Suction Bell-.012" clearance, clean and reuse

**Recommendation:**

- Brush blast to achieve surface profile for epoxy coating
- Coat the interior and exterior with Devtar 5A Grey

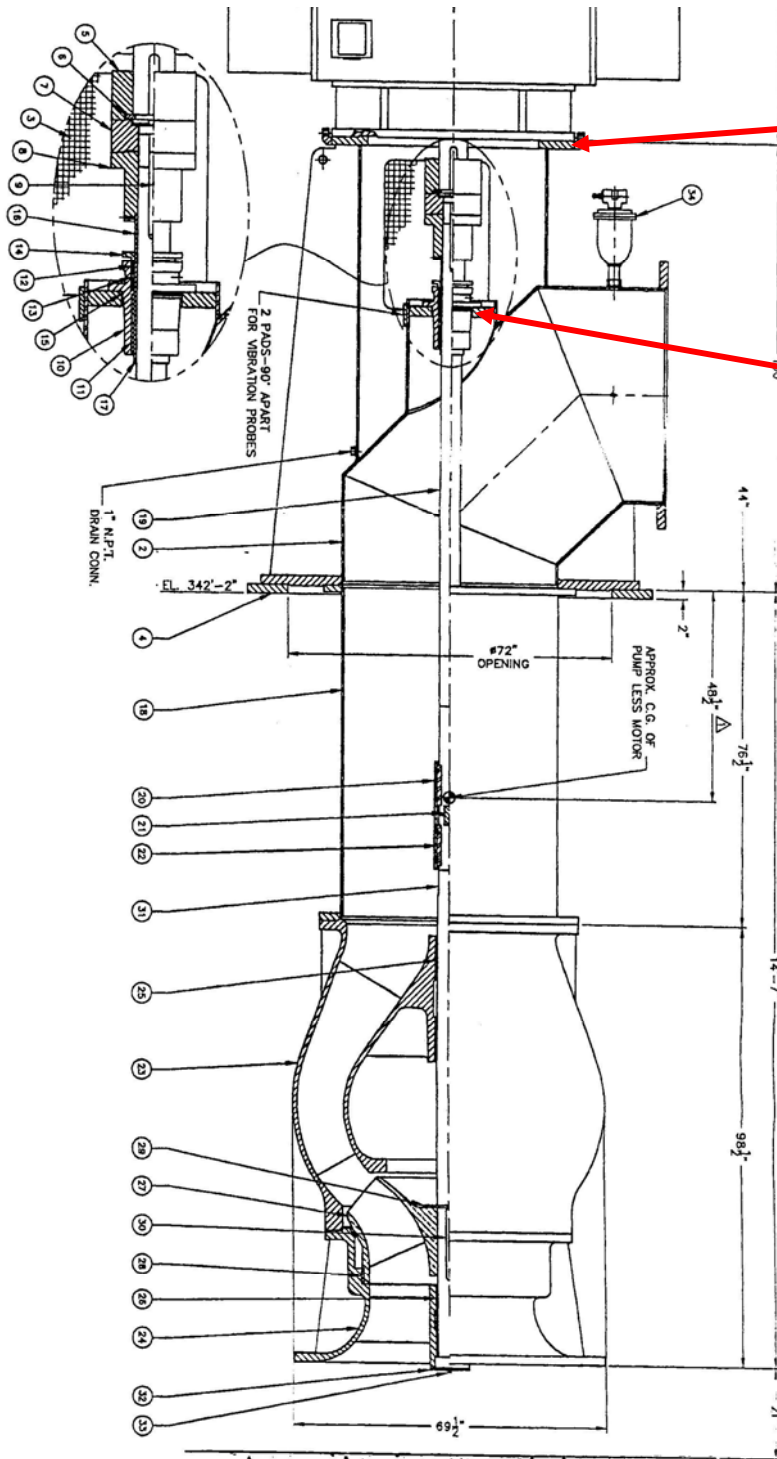
Stuffing box bearing

NOTE: This area should be corrected by machining the flange for the motor mounting surface to be perpendicular to the stuffing box bearing bore
