CIRCULATING WATER PUMP TURNKEY EMERGENCY REPAIR CASE NO AP-321

Chas G Allen received an emergency request to repair a Johnston Model 58KLC-1, rated 58,000GPM @ 46'TDH. The unit provides cooling water to a 550 Mw combine cycle station. CGA received the call from the plant on Sunday to evaluate the unit and found that the shaft had broken internally. As a turnkey service CGA provide field personnel to remove the equipment on a 24/7 basis. The unit was transported to our service center, disassembled and evaluated for a corrective action plan. The internal shaft coupling had fracture and caused the unit failure. A new coupling was manufacture and the pump was reinstalled at the site within six 6 days of the initial call. The following pages include the opening inspection and final report of the project.

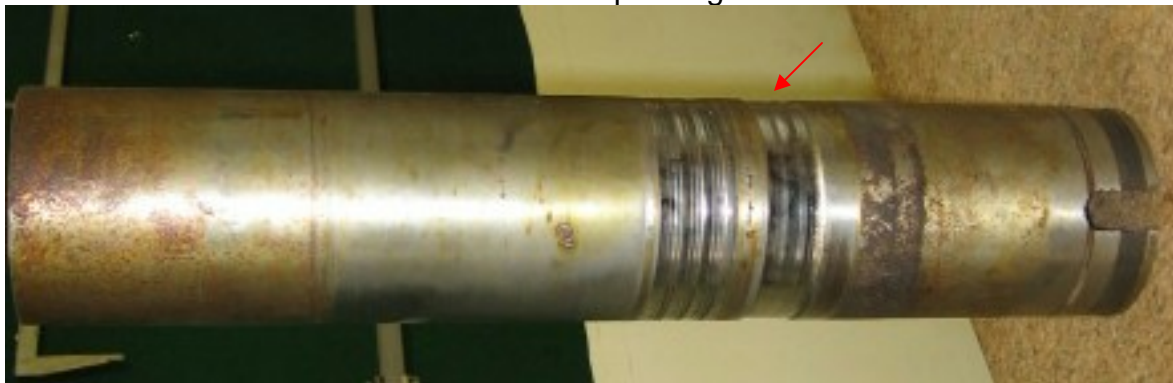
#16 Head Shaft Sleeve-Grooved form the packing

Recommendation:

- Furnish a new head shaft sleeve in 416SS
- Add three dog point set screws to hold sleeve in place
- Furnish a new Buna-N O-Ring
